Culvert Assessment and Prioritization Report

Framingham, MA

MARCH 2021

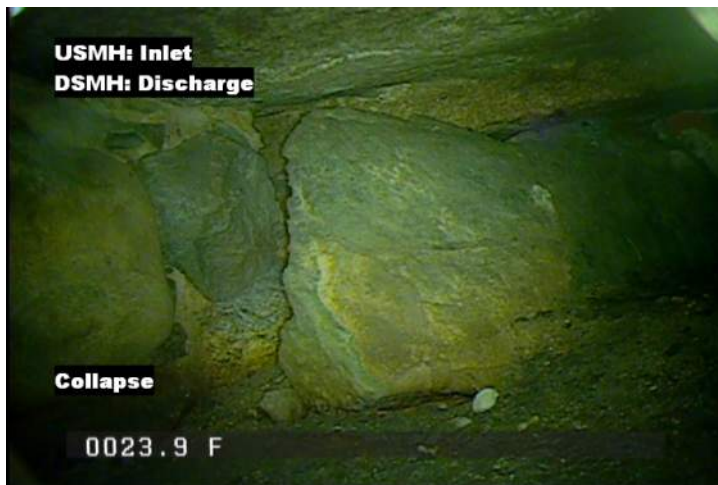
1. Hartford Street, Asset ID: 2505652, Associated Work Order: 122019-027

- Total Risk Score: 83.0
- Cost Estimate for Construction: \$755,000
 - Assumptions for Cost Estimate:* Replacement of culvert with a 6' x 3' concrete box culvert, replacement of headwalls, dredging adjacent property
- Roadway Classification: Arterial
- Criteria Rated Critical: Level of Blockage, Cross-Section Deformation, Structural Integrity of Barrel, and Buoyancy or Crushing
- Summary of Culvert Condition: The culvert is half stone and half reinforced concrete. CCTV indicates a collapse in center of the stone culvert blocking flow though the culvert (Photo 1). Downstream headwall and wingwall have loose stones and are leaning outward.

Photo 1 Hartford Street culvert, interior collapse

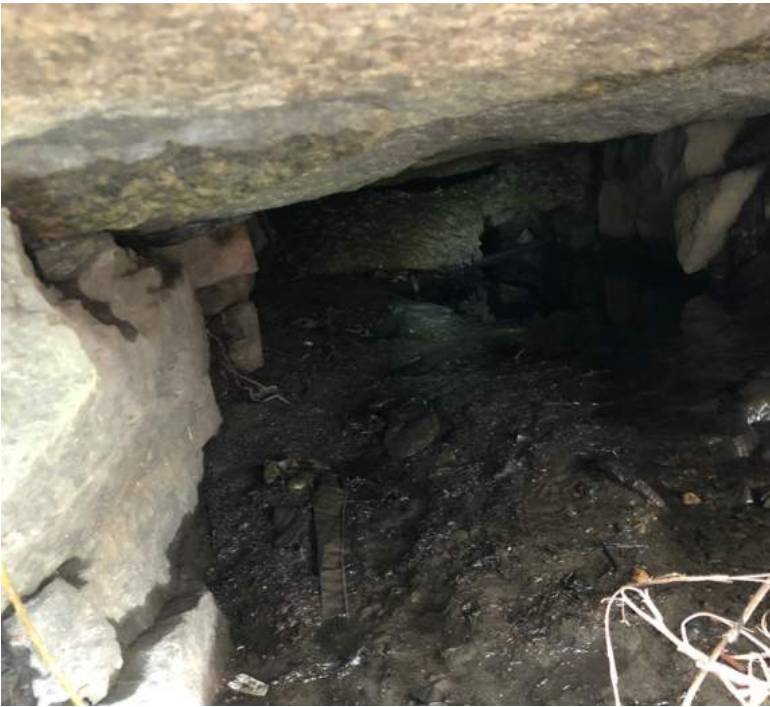
2. Herbert Street, Asset ID: 2511942, Associated Work Order: 122019-034

- Total Risk Score: 77.0
- Cost Estimate for Construction: \$285,000
 - Assumptions for Cost Estimate:* Replacement of culvert with 42" x 24" concrete box culvert, replacement of headwalls
- Roadway Classification: Local
- Criteria Rated Critical: Level of Blockage, Cross-Section Deformation, Structural Integrity of Barrel, and Joints and Seams
- Summary of Culvert Condition: Stone collapse within culvert blocking flow through the culvert (Photo 2). The upstream invert is completely buried causing stagnant water at the upstream headwall (Photo 3).

Photo 2 Herbert Street culvert, interior collapse

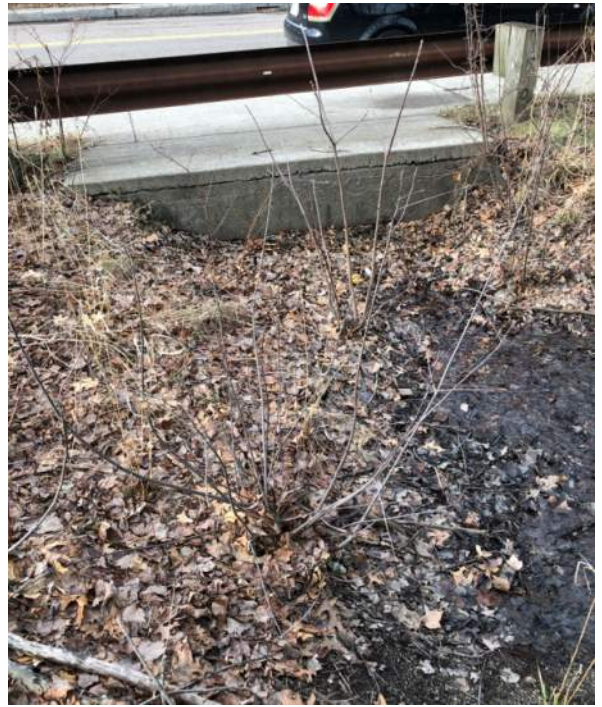
Photo 3 Herbert Street culvert, upstream blockage

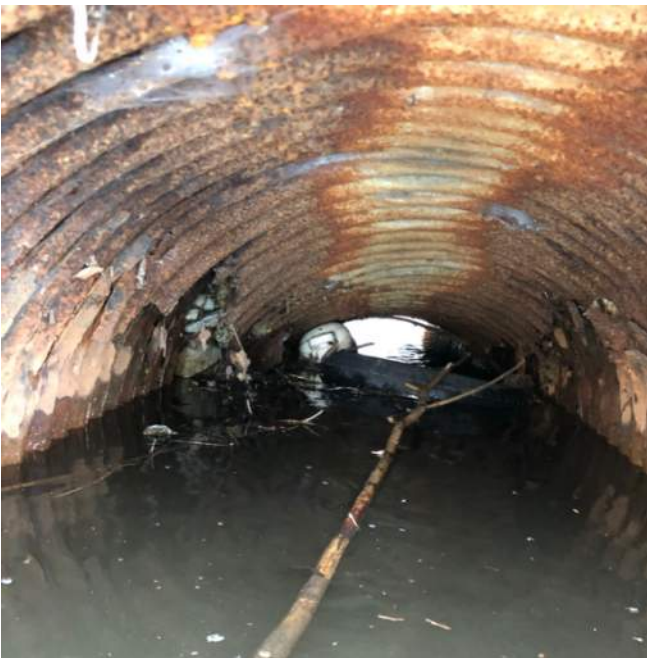
3. **Bates Road Extension, Asset ID: 2515114, Associated Work Order: 122019-030**

Photo 4 Waushakum Brook, deformation, second from left culvert

Cost Estimate Assumptions: Costs were estimated for 2 scenarios- replacement of the culvert with a 20' Bridge or removal of crossing and restoration of Waushakum Brook with a rip rap lined open channel. Both estimates include FEMA no-rise certificate permitting.

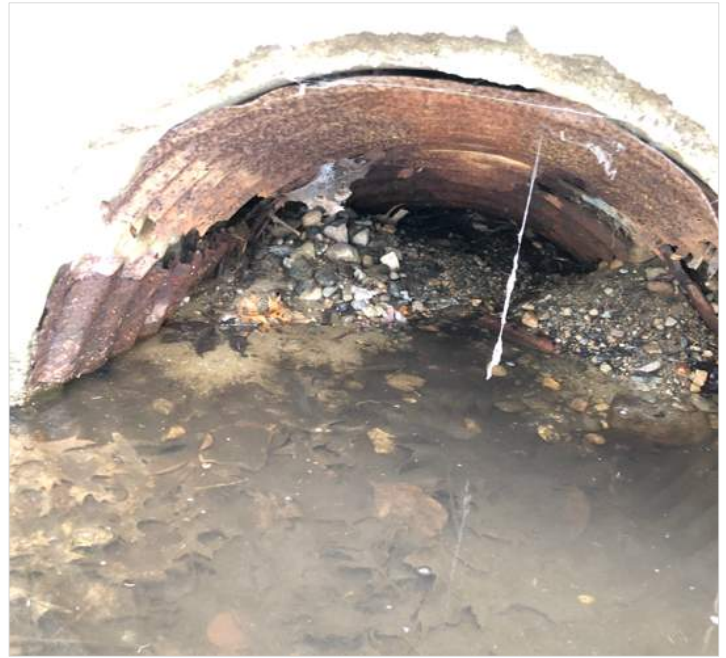
Photo 5 Waushakum Brook, interior collapse in left culvert

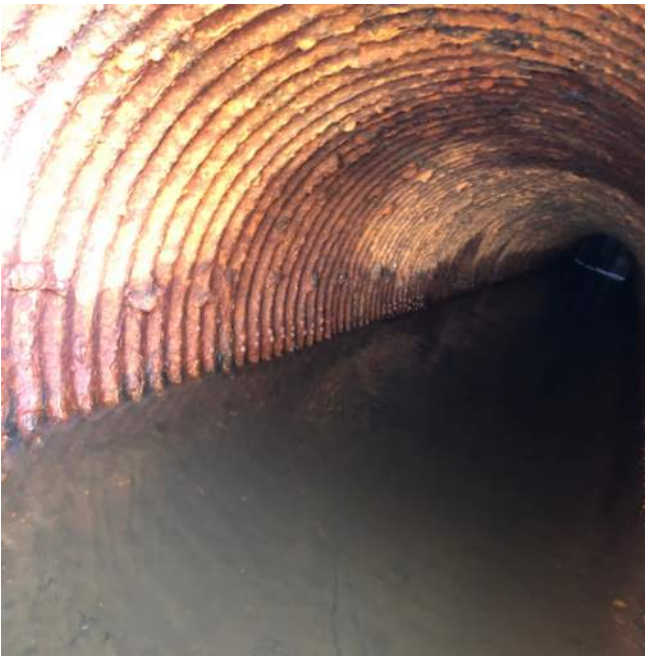
4. Gates Street, Asset ID: 2506907, Associated Work Order: 122019-059

- Roadway Classification: Collector
- Criteria Rated Critical: Structural Integrity of Barrel
- Summary of Culvert Condition: The CMP culvert has significant rusting throughout entire barrel (Photo 6). The upstream headwall includes an outlet control structure (OCS) with gate and a 6" opening at the bottom of gate (Photo 7). The gate opening tracks are significantly deteriorated. Some exposed rebar is visible on the structure. On the downstream side, the top of projecting CMP is completely deteriorated. The downstream end of culvert is submerged in stagnant water. The Massachusetts Water Resources Authority (MWRA) operates the downstream reservoir, so upgrades to this culvert may require MWRA approval.

Photo 6 Gates Street culvert, interior deterioration

- Total Risk Score: 75.1
- Cost Estimate for Construction: \$988,000
 - Assumptions for Cost Estimate:* Replacement of culvert with 12' x 6' concrete box culvert, replacement of headwalls, replacement of outlet control, hydraulic study and flood analysis

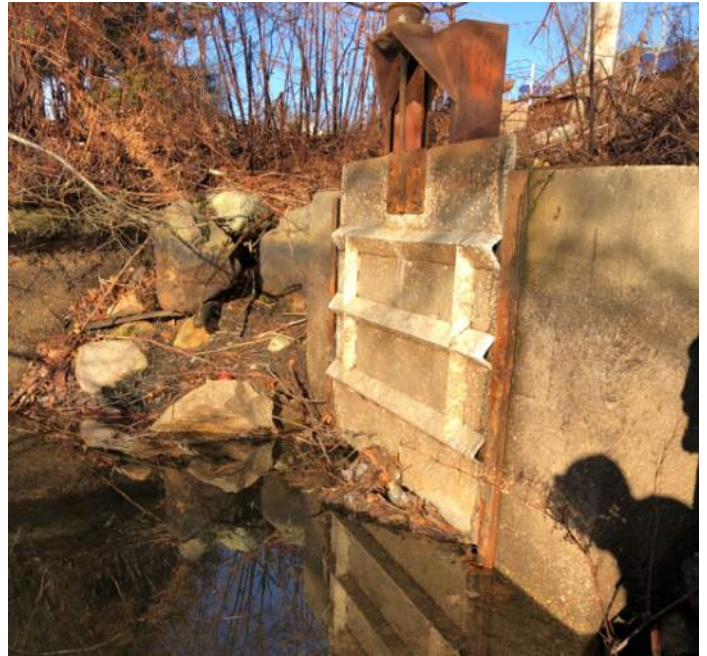
Photo 7 Gates Street culvert, rusted OCS gate

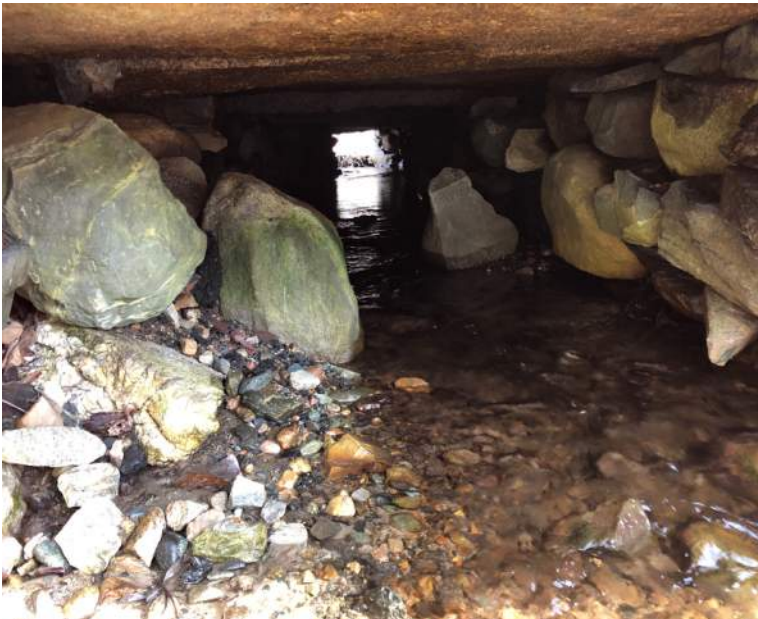
5. Wayside Inn Road, Asset ID: 2511788, Associated Work Order: 122019-083

- Total Risk Score: 74.3
- Cost Estimate for Construction: \$303,000
 - Assumptions for Cost Estimate:* Replacement of culvert with 8' x 4' concrete box culvert, replacement of upstream headwall
- Roadway Classification: Collector
- Criteria Rated Critical: Footings
- Summary of Culvert Condition: Many stones in the culvert have fallen out of place (Photo 8). Although the culvert is currently functioning, the fallen stones have left voids in the wall which reduces the structural stability of the stone culvert. Embankment erosion is present along downstream headwall (Photo 9).

Photo 8 Wayside Inn Road culvert, fallen interior stones

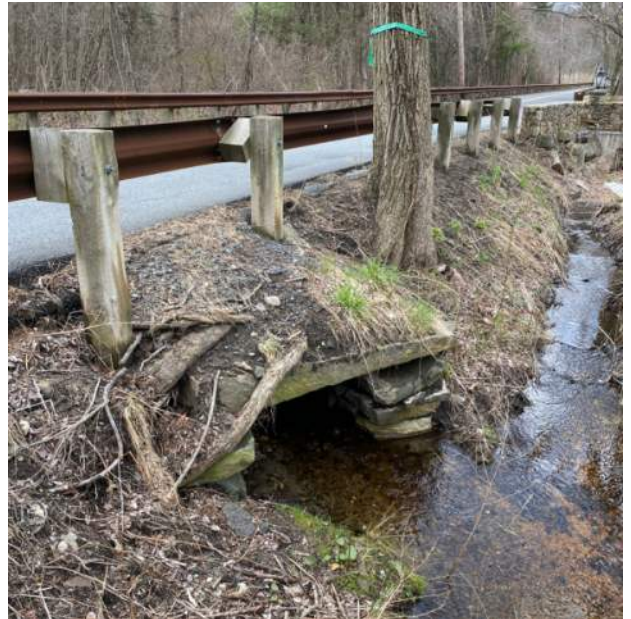
Photo 9 Wayside Inn Road culvert, downstream embankment erosion

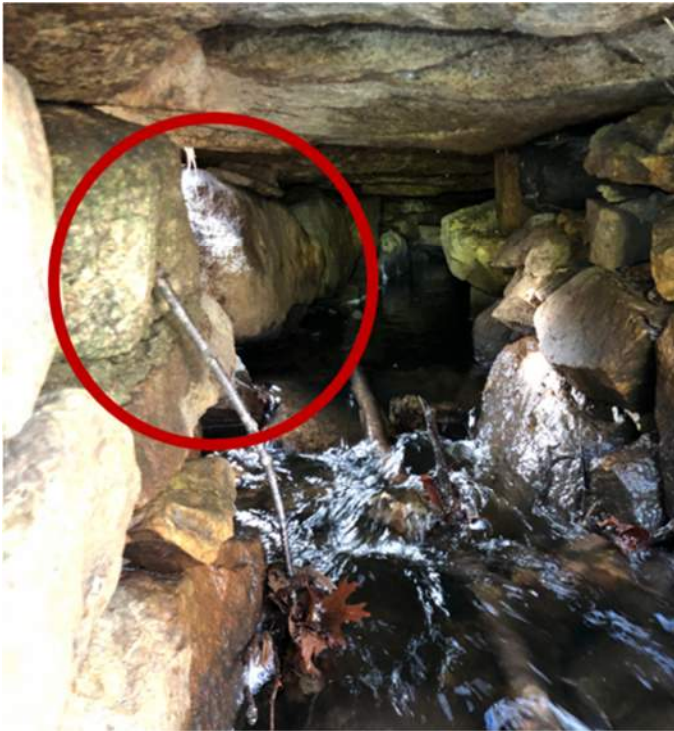
6. Salem End Road, Asset ID: 2511831, Associated Work Order: 122019-087

- Roadway Classification: Local
- Criteria Rated Critical: Cross-section Deformation and Structural Integrity of Barrel
- Summary of Culvert Condition: The stone culvert is lined with a concrete pipe in the upstream section. There is a failure near the downstream end of the culvert, where there is a collapse of the roof of the stone culvert (appears to be located on private property) (Photo 10). A hole, approximately a foot in diameter, can be seen at the surface (Photo 11). The downstream stone headwall has portions of loose mortar.

Photo 10 Salem End Road culvert, interior stone roof collapse

Assumptions for Cost Estimate: Replacement of culvert is 12' x 6' concrete box culvert, replacement of headwalls

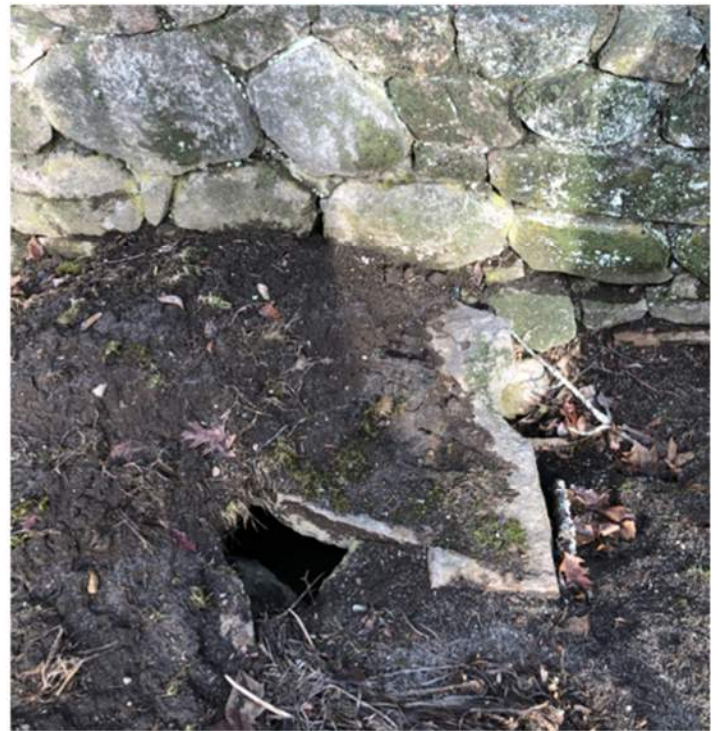
Photo 11 Salem End Road culvert, exterior hole in culvert roof

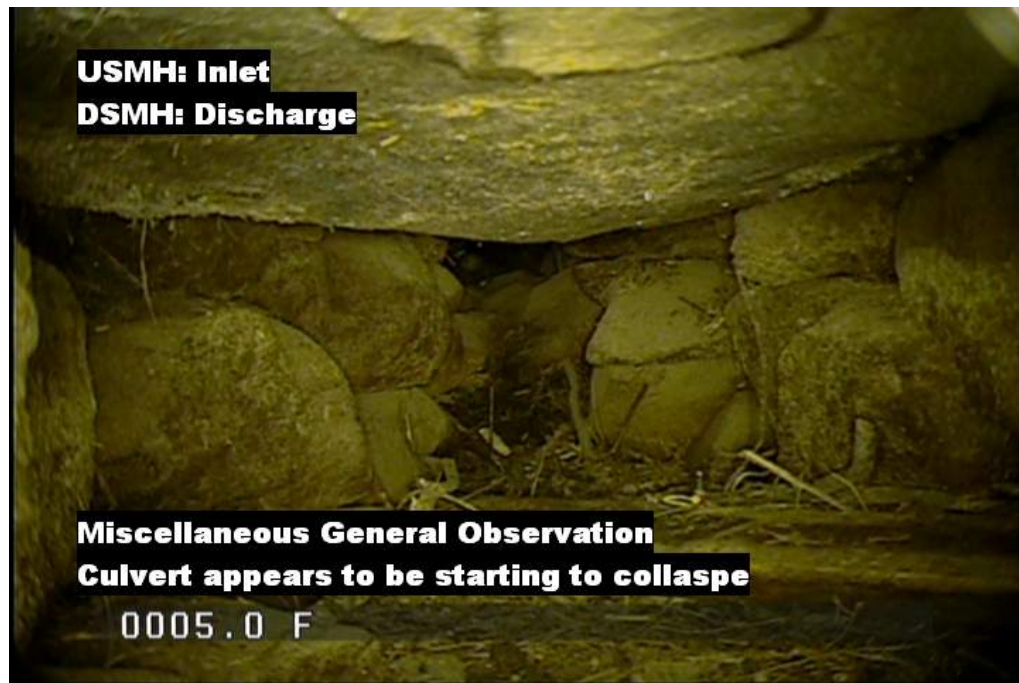
7. Parmenter Road, Asset ID: 2511778, Associated Work Order: 122019-080

- Total Risk Score: 71.1
- Cost Estimate for Construction: \$244,000
 - Assumptions for Cost Estimate:* Replacement of culvert with 7' x 4' concrete box culvert, replacement of headwalls
- Roadway Classification: Local
- Criteria Rated Critical: Cross-section Deformation and Structural Integrity of Barrel
- Summary of Culvert Condition: The upstream headwall is composed of wood being held in place by a steel post. The downstream headwall is stone that shows beginning signs of settlement. CCTV indicates the stone culvert is beginning to collapse internally (Photo 12). The small hydraulic opening creates high potential for blockage to occur.

Photo 12 Parmenter Road culvert, interior collapse (CCTV)

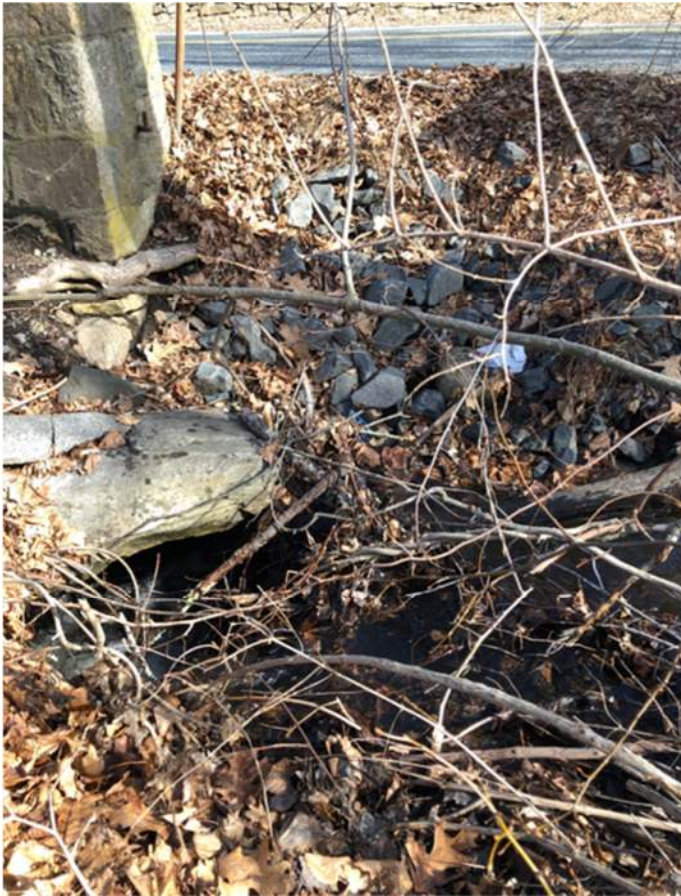
8. Badger Road, Asset ID: 2506912, Associated Work Order: 122019-094

- Total Risk Score: 69.2
- Cost Estimate for Construction: \$449,000
 - Assumptions for Cost Estimate:* Replacement of culvert with 9' x 5' concrete box culvert, replacement of headwalls
- Roadway Classification: Collector
- Criteria Rated Critical: Level of Blockage and Headwall/Wingwalls
- Summary of Culvert Condition: The upstream stone headwall is collapsed, causing a small hydraulic opening. Erosion is present from the roadway at the upstream headwall (Photo 13). The stream runs parallel to the roadway before entering the stone culvert and flowing perpendicular under the roadway. The downstream stone headwall has a major failure (Photo 14).

Photo 13 Badger Road culvert, upstream headwall collapse and erosion

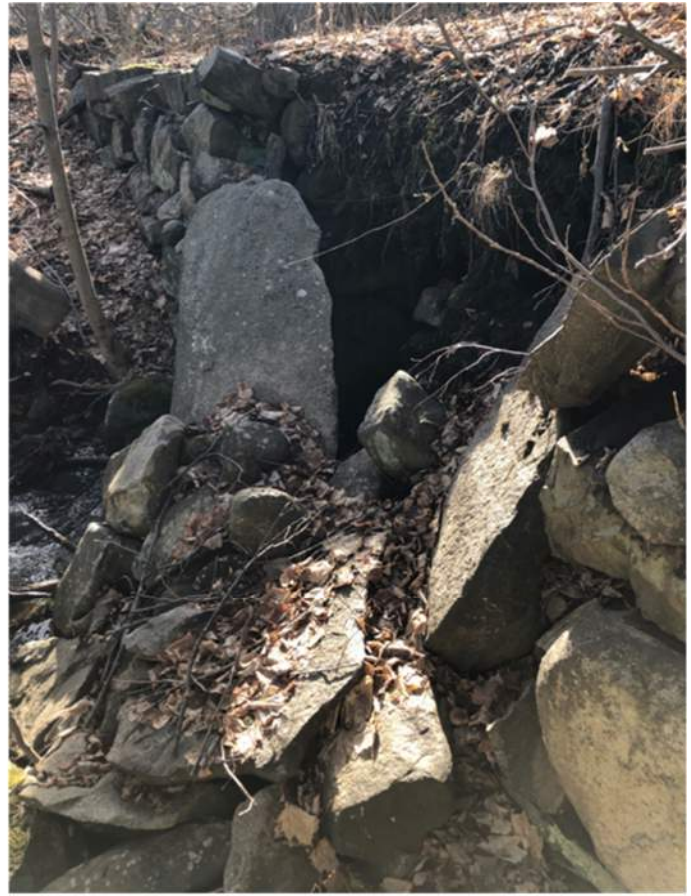
Photo 14 Badger Road culvert, downstream headwall collapse

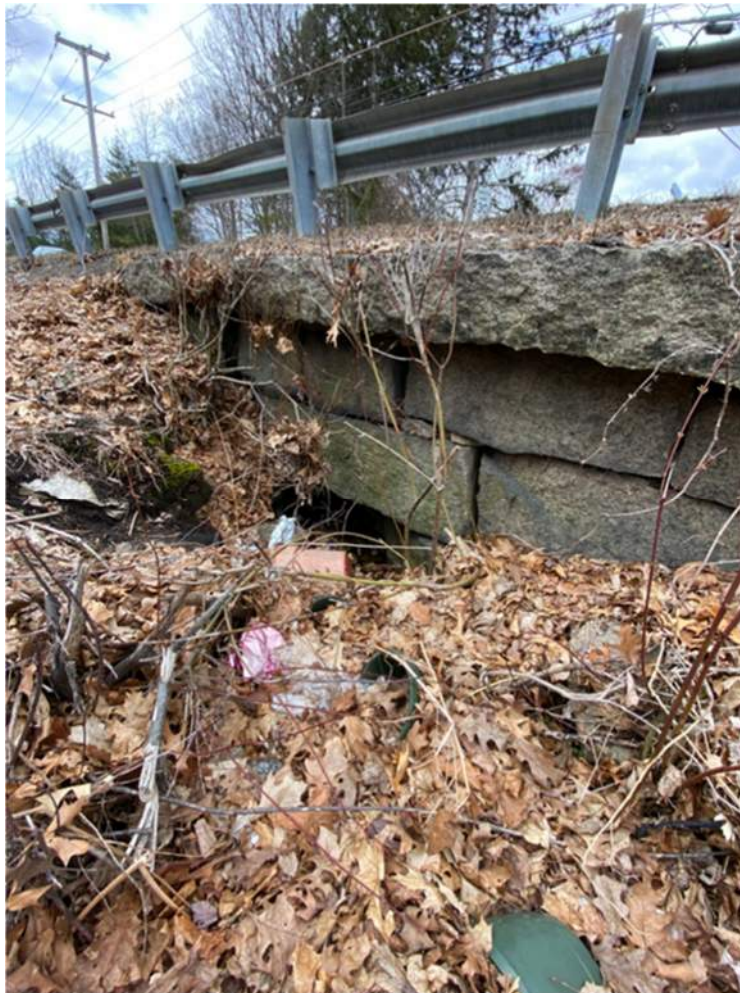
9. Fountain Street, Asset ID: 2506913, Associated Work Order: 122019-060

- Total Risk Score: 61.5
- Cost Estimate for Construction: \$412,000
 - Assumptions for Cost Estimate:* Replacement of culvert with 8' x 4' concrete box culvert, replacement of headwalls
- Roadway Classification: Collector
- Criteria Rated Critical: Level of Blockage, Headwall/Wingwalls
- Summary of Culvert Condition: The upstream invert of the stone culvert is buried. The upstream channel is dry and filled with debris (Photo 15). The downstream invert has backwater from the downstream lake. The downstream headwall has loose stones. The downstream wingwall has missing stones which have fallen into the channel.

Photo 15 Fountain Street culvert, upstream headwall

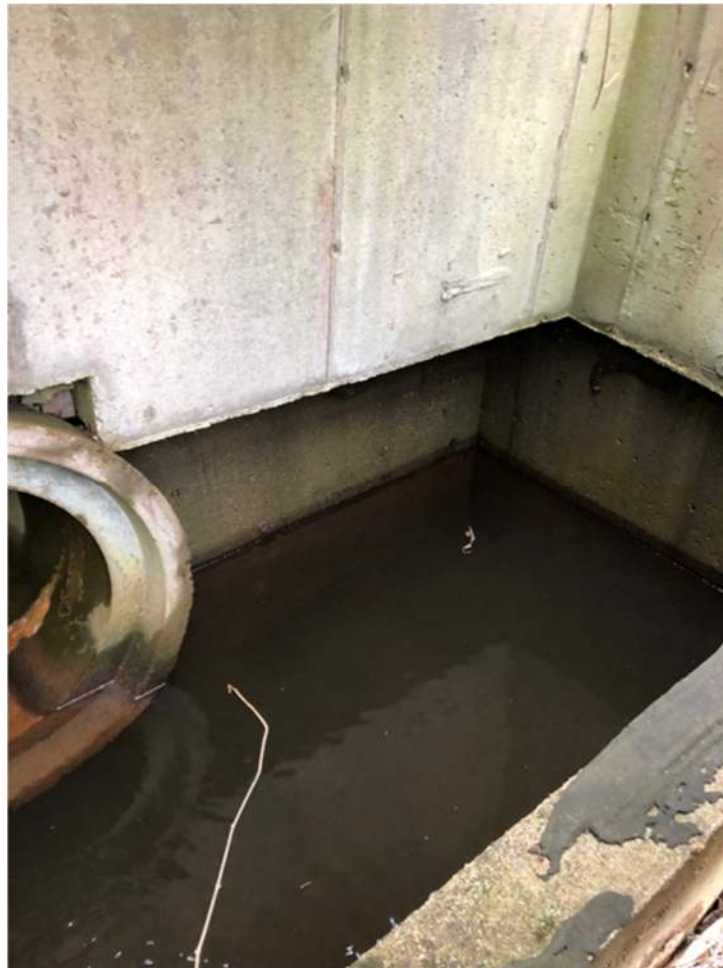
10. Garvey Road, Asset ID: 2511728, Associated Work Order: 122019-115

- Total Risk Score: 60.3
- Cost Estimate for Construction: \$228,000
 - Assumptions for Cost Estimate:* Replacement of outlet control structure
- Roadway Classification: Local
- Criteria Rated Critical: Headwall/Wingwall
- Summary of Culvert Condition: The outlet control structure at the inlet superstructure has dislodged outward, approximately one foot from the substructure with minimal headwall backfill (Photo 16). It is our understanding that proposed nearby roadway improvements or pump station project can be coupled with the culvert repair, which would likely reduce the cost of replacement.

Photo 16 Garvey Road culvert, inlet dislodged OCS superstructure
